DEMONSTRATION OF A FULL-SCALE RETROFIT OF THE ADVANCED HYBRID PARTICULATE COLLECTOR TECHNOLOGY

TECHNICAL PROGRESS REPORT

April 2004 – June 2004

Otter Tail Power Company
Big Stone Plant
PO Box 218
Big Stone City, SD 57216-0218

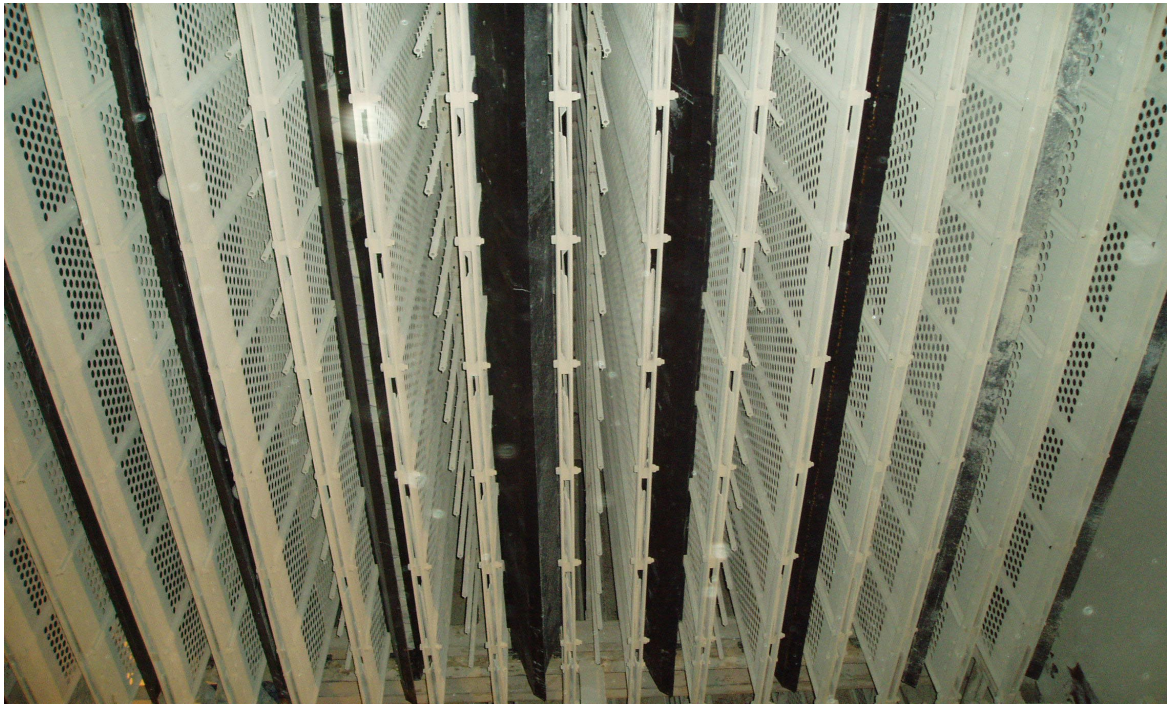
- a. SEI was contracted to fabricate and install 57 sets of bag row baffles. The baffles were installed in all compartments of chamber 2B.
 - i. Half of the baffles had to be modified because of incorrect fabrication.
 - ii. Once the modifications were made, all three compartments were installed in only two days.
 - iii. The decision was made to tack weld the nuts on to support bracket bolts and also to tack weld the ends of the baffles near the bottom to maintain a 2-inch gap.
 - iv. There is some concern surrounding the clearance between the bag and the cut out portion of the end baffles.

Figure 1: Installed baffles viewed from below.

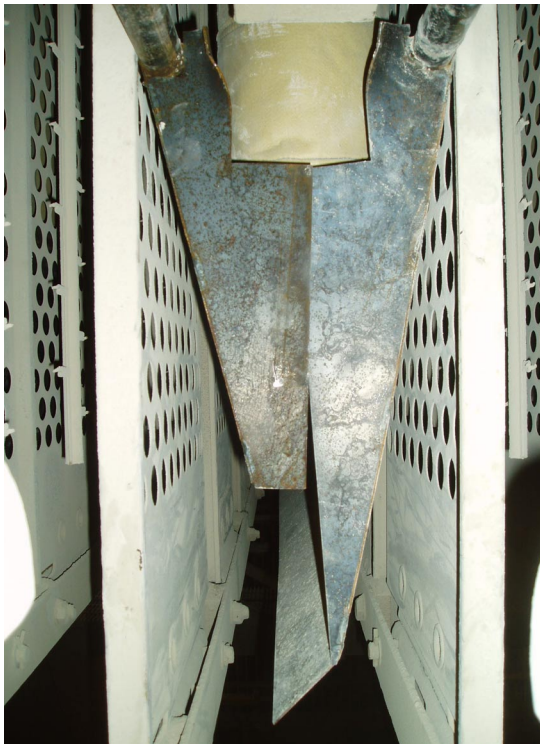
Figure 2: End baffle without tack weld

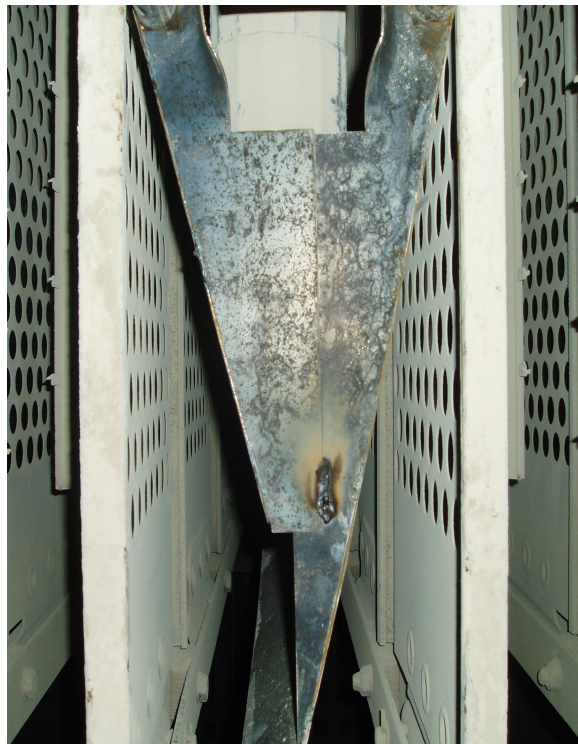
Figure 3: End baffle with tack weld

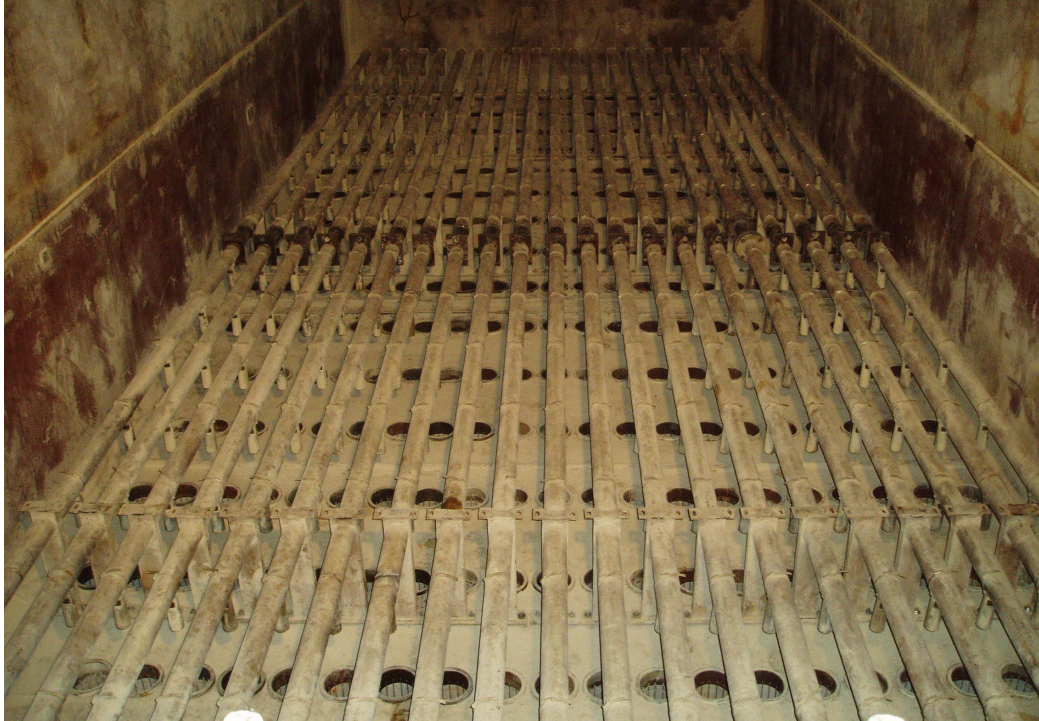
- a. One compartment of blowpipes was modified in 1BF3 (see Figure 4)
- b. Flat bar was used to seal off the holes for the top header (see Figure 5)

Figure 4: Modified blowpipes in 1BF3

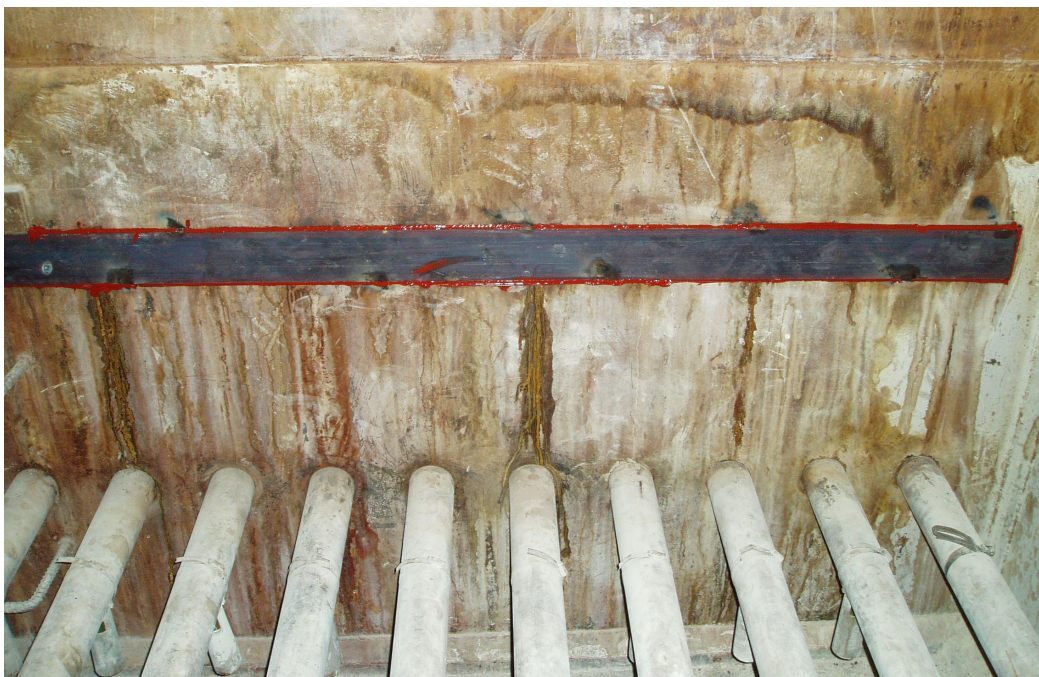
Figure 5: Flat bar used to cover holes in plenum wall

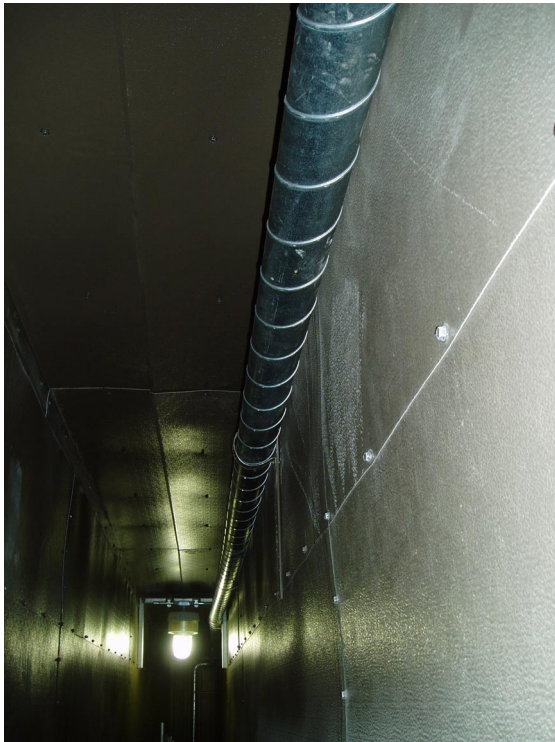
- a. SEI repaired four girder box and bus duct purge air supply lines. The PVC lines installed in Oct. 2002 were warped due to heat. Metal ducting was installed (see Figures 6-7).

Figure 6. New girder box purge line

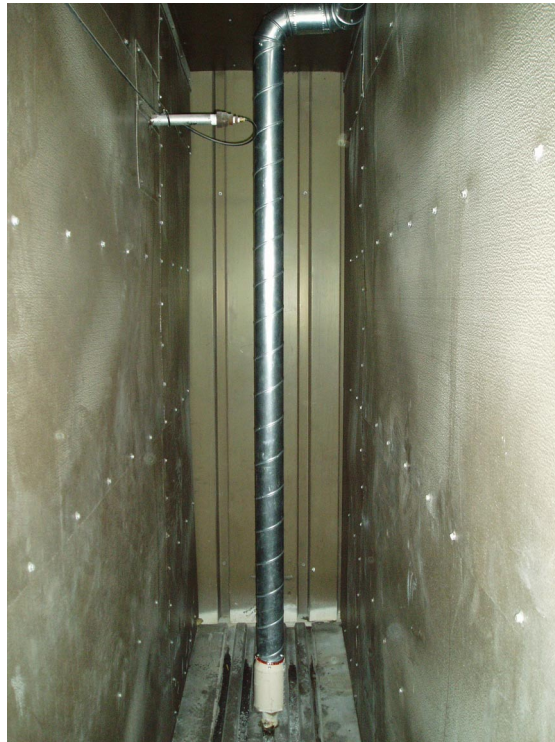
Figure 7: Purge line interface to girder box

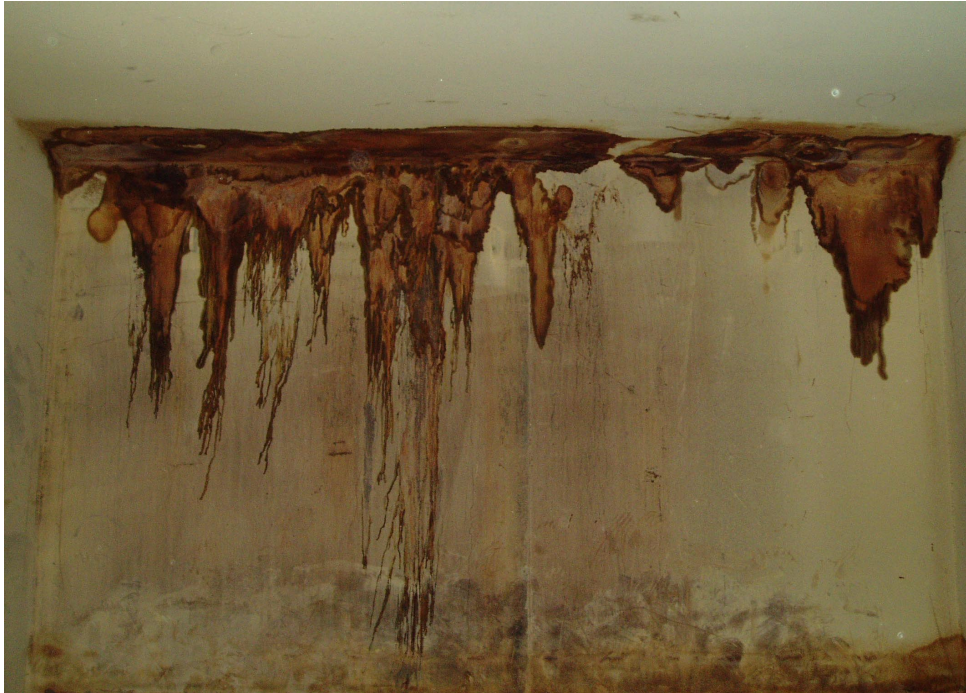
- i. No ash buildup in the girder boxes.
 - ii. No cracked insulator crocs reported.
- d. Clean Gas Plenums
 - i. Amount of corrosion on ceilings has increased from last inspection (see Figure 8). Noted water dripping in around one top hatch (see Figure 9).

Figure 8. Corrosion on plenum ceiling

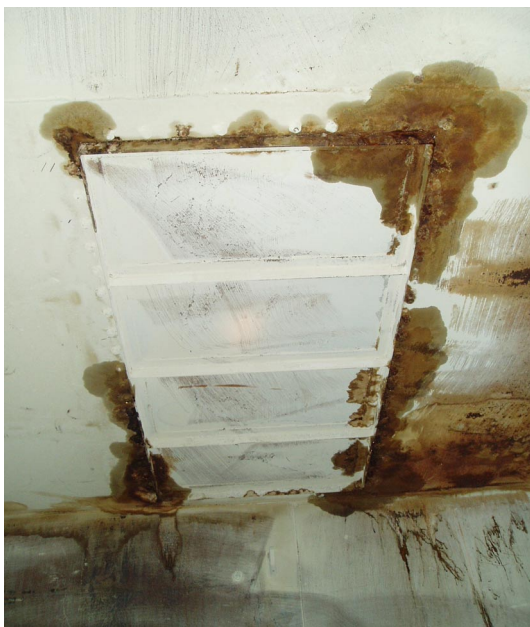
Figure 9. Plenum top hatch corrosion

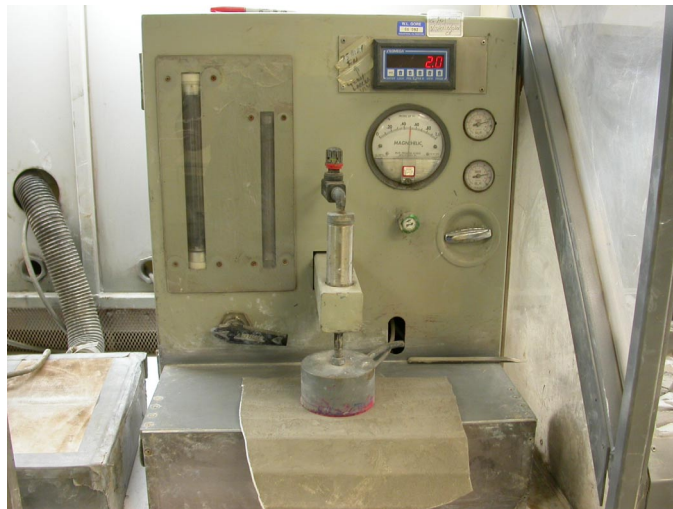
The air permeability analysis of the filter bag media was performed in the lab using the Frazierometer.

Permeability is the volumetric flow rate of air, measured in cubic feet per minute (cfm) through a square foot of filter media at a pressure differential of 0.5 inches water gauge (w.g.). The unit of measure is cfm/ft² @ 0.5" w.g. and is called the Frazier Number (Fn). Samples of the *Advanced Hybrid®* filter bag media were cut from the top, middle, and bottom bag locations. The sample size was five inches in the vertical bag length direction along the entire circumference of the bag. Typically three measurements per bag sample were taken. An average value is then calculated from the nine measurements per bag.

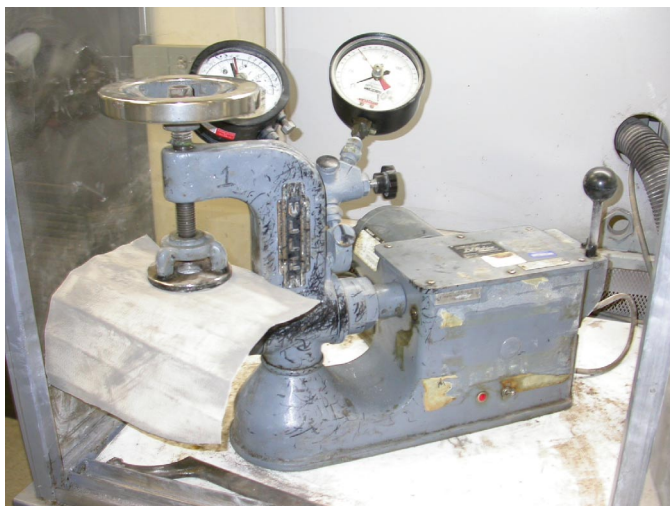
Mullen burst tests were run on a portion of samples taken for the air permeability measurements.

The test consists of applying pressure in the reverse direction of airflow on a three inch diameter filter bag sample, continuously increasing the pressure until the sample is ruptured.
